Need for a Multi-Sensor Monitoring Approach for Embankment Failures: Lessons Learned from the Edenville Dam Failure

Key Terms: *Embankment Failure, Edenville Dam, Synthetic Aperture Radar, Persistent Scatterer Interferometry, Soil Moisture Index*

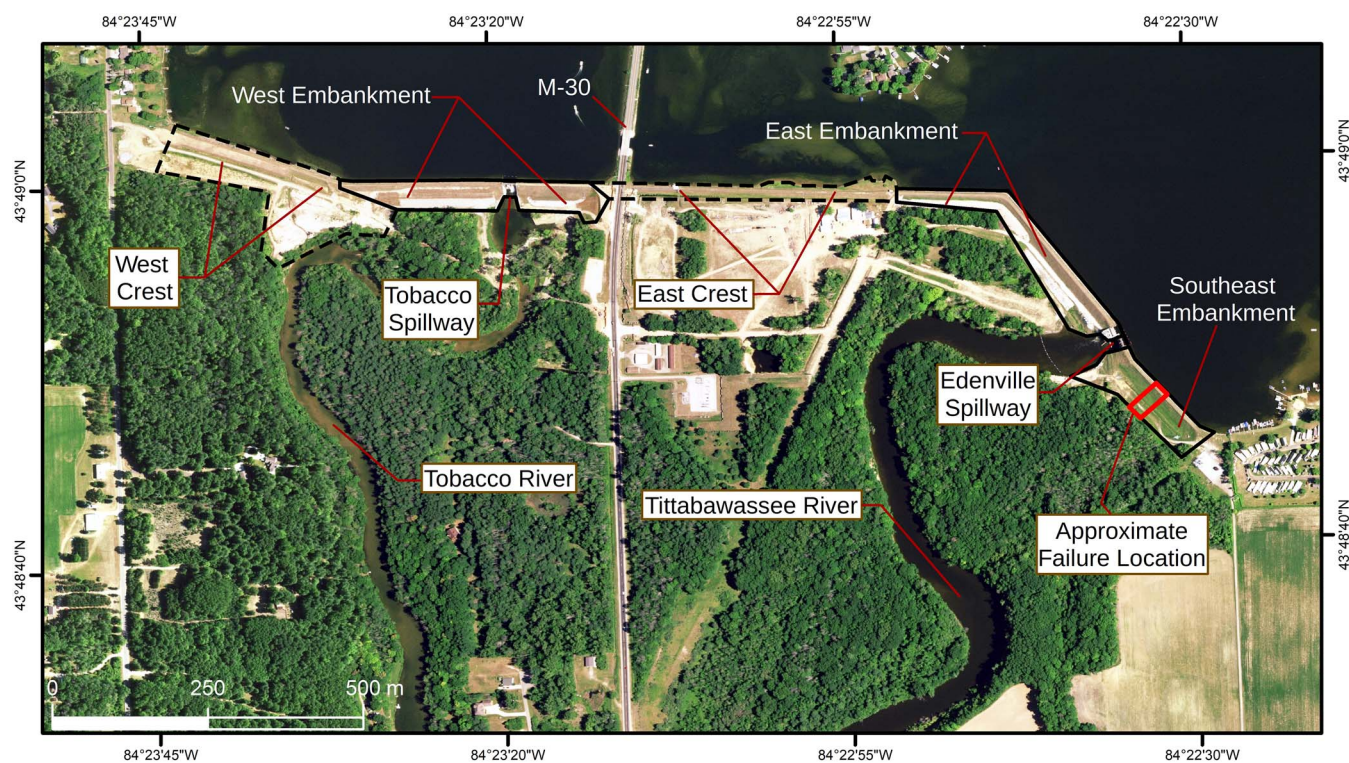
The Tittabawassee section is comprised of the southeast embankment, east embankment, and east crest. The southeast embankment begins south of the Edenville Spillway and extends southeast, approximately 650 ft (198 m) to the east abutment. The height of the southeast embankment ranged between 52 ft (15.8 m) immediately south of the spillway to 30 ft (9.1 m) toward the abutment. The approximate failure location is shown in Figure 2, and the height of the failure location was between 30 and 32 ft (9.1 and 9.8 m) (France et al., 2022). The

Figure 2. Edenville Dam site layout image. Highway M-30, shown in the center of the image, divides the dam into the Tobacco (western) and Tittabawassee (eastern) sections. (Background aerial image is courtesy of National Agriculture Imagery Program [NAIP], image captured on July 16, 2016 and accessed from the U.S. Geological Survey [USGS] Earth Explorer website: <https://earthexplorer.usgs.gov>.) The approximate failure location is shown in red.

east embankment and east crest are continuous embankments, but they were again separated in this study due to varying embankment heights. The east embankment extends from the Edenville Spillway 1,300 ft (396 m) to the east crest. The east crest extends 1,450 ft (442 m) from the east embankment to M-30. The average heights of the east embankment and east crest are 40 and 15 ft (12.2 and 4.6 m), respectively. Similar to the Tobacco section, the upstream and downstream slopes of the embankments were originally constructed at a ratio of 2.5H:1V (horizontal to vertical) and 2H:1V, respectively (France et al., 2022). Surveys conducted after the flood show that some sections of both the upstream and downstream embankments are steeper than the initial design ratio (France et al., 2022).

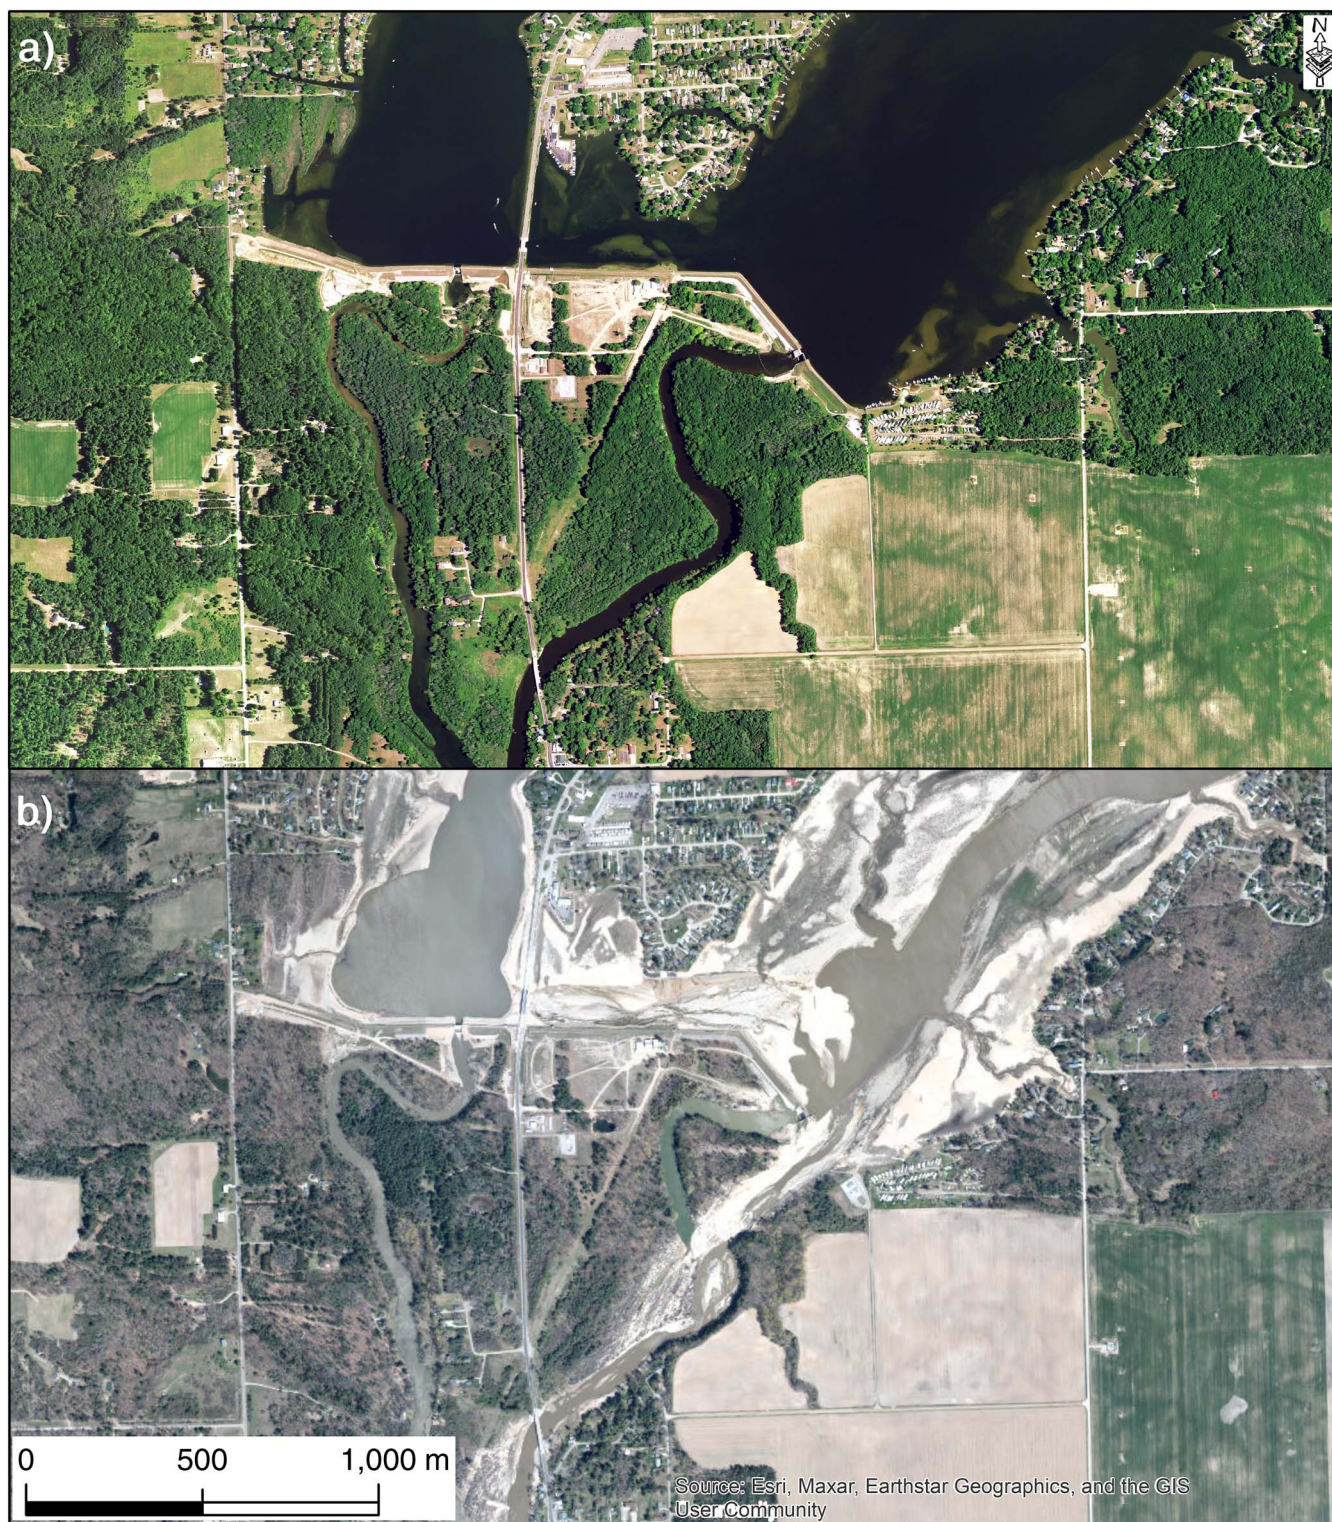
Figure 3. (a) Pre-failure and (b) post-failure imagery of the Edenville Dam. The approximate failure location where the depression was observed is shown in red. (Pre-failure imagery: NAIP image; post-failure imagery: ArcGIS world imagery.)

5.5 ft (1.68 m) higher than normal operating levels (approximately 1.5 ft [0.46 m] below the crest elevation of the southeast embankment). The failure widened throughout the evening of May 19, and Wixom Lake

was emptied. Figure 3 presents a pre- and post-failure comparison of the Edenville Dam. It was also reported that the downstream embankment slope was not uniform and was over-steepened in areas, and a bulging feature

was present in a 2017 light detection and ranging (LiDAR) survey. A slope stability model showed a low factor of safety (1.08) for a rotational slide when modeled with the reservoir level at the time of failure.

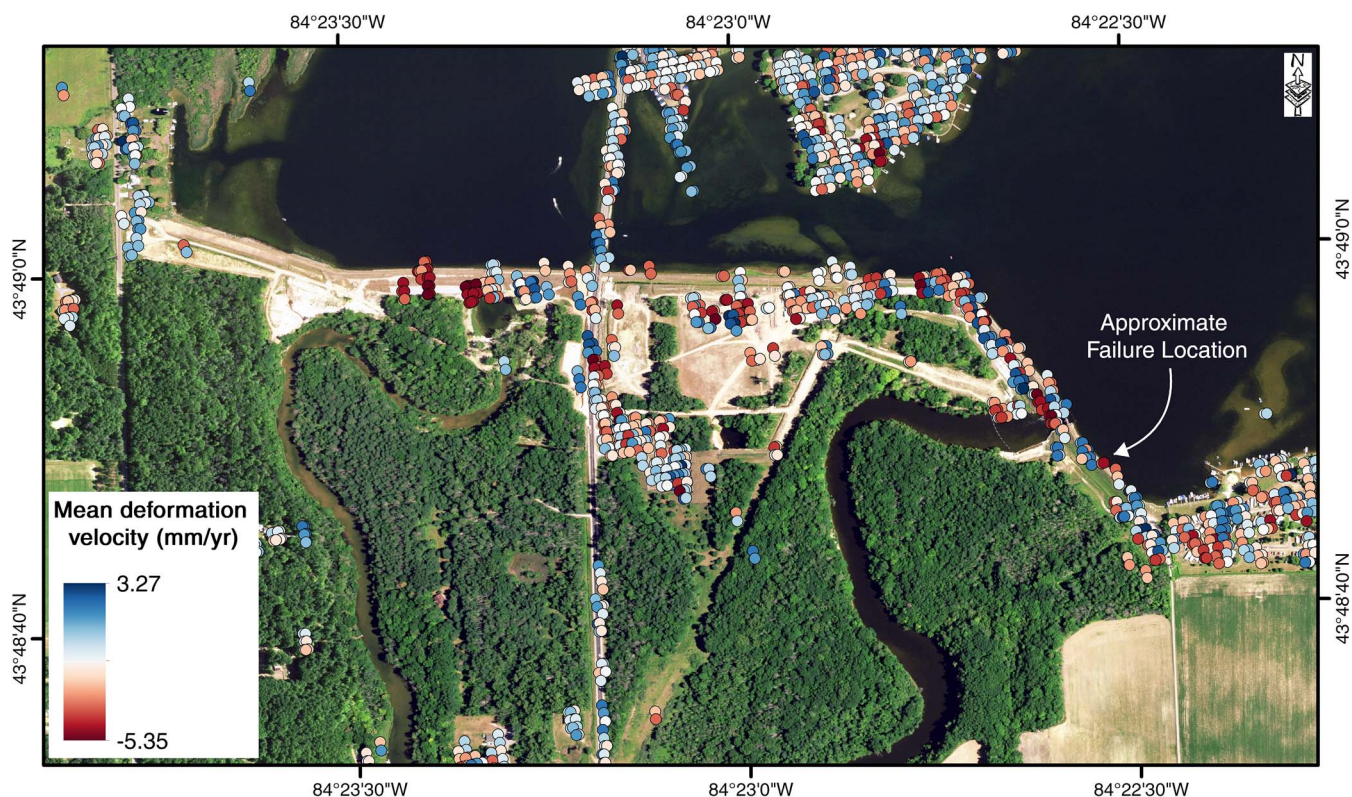
Figure 4 Average velocity (mm/yr) between December 2, 2016, and May 3, 2020, measured using 97 Sentinel-1 images with PSI processing.

region, is shown in Figure 4. The mean deformation velocity of the region varied between -5.35 mm/yr and 3.27 mm/yr. The mean deformation velocity was measured in the line-of-sight (LOS) direction (approximately $N80^{\circ}E$, 40° to nadir), where positive and negative values were PS targets moving toward (i.e., upward) and away (e.g., downward) from the satellite, respectively (Vassileva et al., 2017). Three areas of interest (AOIs) were identified to compare the movement along the dam outline: the west embankment, the east embankment, and the southeast embankment where the failure occurred. The three embankments included in the AOIs had a difference in elevation from the reservoir to the toe of the dam between 8 and 12 m. The southeast embankment containing the failure location begins immediately southeast of the Edenville Spillway and extends southeast to the easternmost abutment. The mean (standard deviation) deformation velocity for the PSI measurements of the west, east and southeast embankments were -1.1 mm/yr (1.8 mm/yr), -0.1 mm/yr (1.5 mm/yr), and -0.5 mm/yr (1.1 mm/yr), respectively (Table 2). This variability in InSAR resulted from the heavily vegetated floodplain environment and coarse spatial resolution relative to the narrow embankment system. The average cumulative displacements of the east, west, and southeast embankments showed no major differences and were -21.3 mm, -47.5

mm, and -33.2 mm, respectively. Most PS targets in all three AOIs had deformation velocities that fell within two standard deviations. Although the southeast embankment is considered to represent an unstable area of the dam, as the failure occurred within this AOI, insufficient numbers of PS targets were resolved within the approximated failure location.

The results of the PSI analysis of the Edenville Dam did not provide any significant observations supporting the deformation of the southeast embankment and apparent displacement at the failure location over the period of study. Although the southeast embankment recorded a negative displacement, the magnitude was not significant (within two standard deviations) and was comparable with the east and west embankments, representing

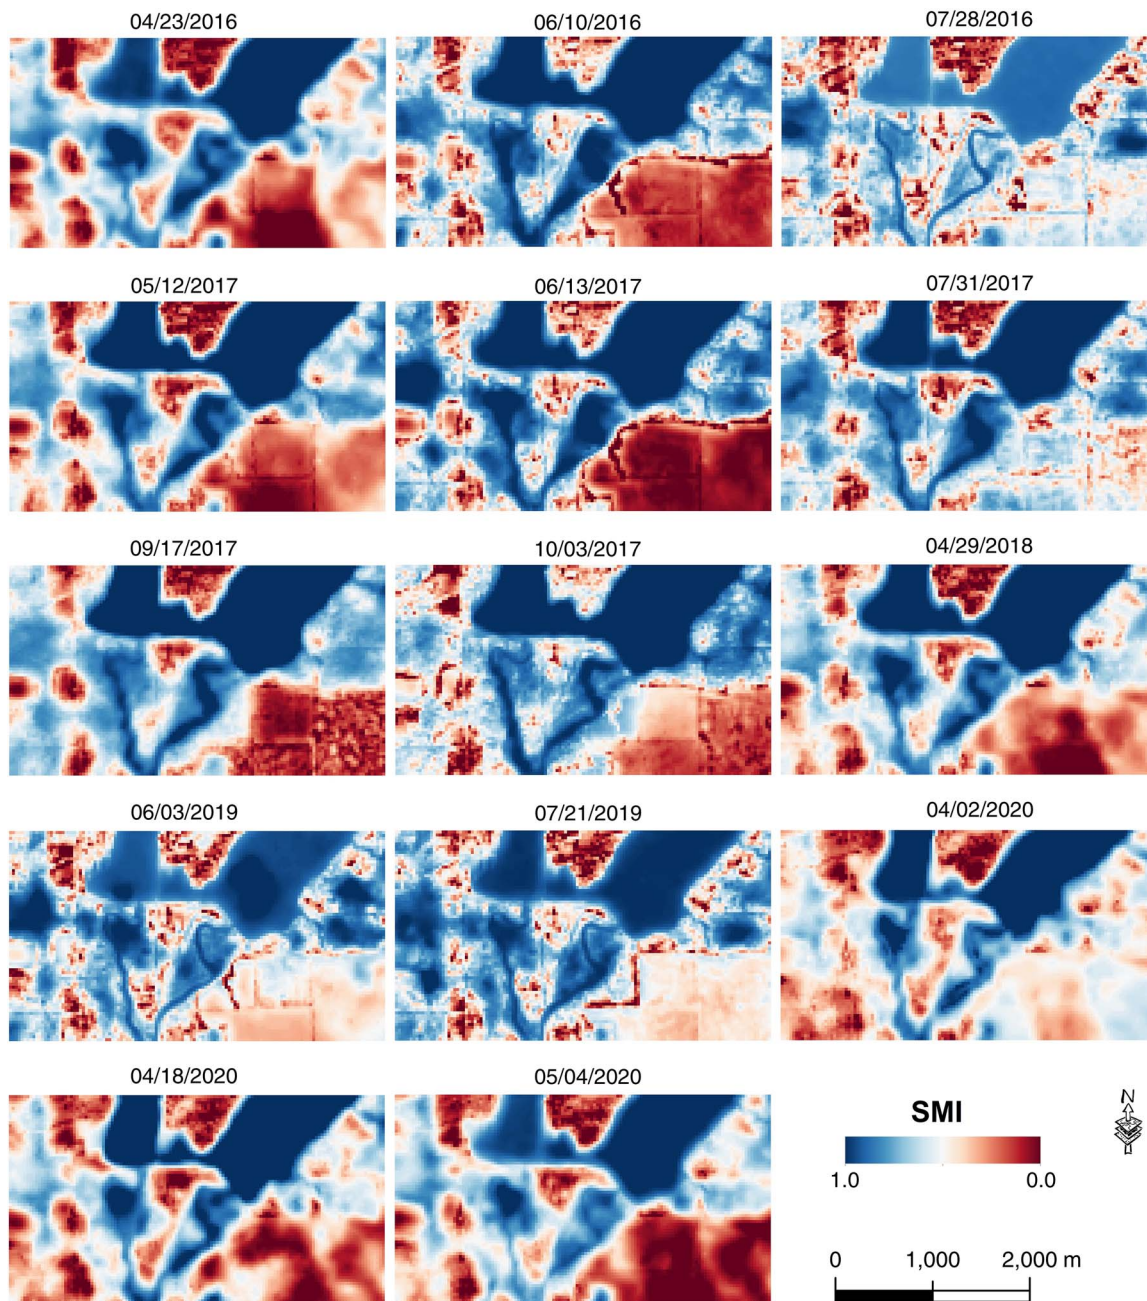
The SMI representing relative moisture in the study area was derived from the Landsat 8 images between April 23, 2016, and May 4, 2020 (Figure 5). The standard deviation of the SMI time series is shown in Figure 6. The SMI scenes were not evenly distributed over time due to the lack of cloud-free images. Based on the standard deviation, the areas with the greatest variability in the entire scene were the agricultural fields shown in the southeast corner and the two “bull’s-eye” features along the western edge of the scene, with values ranging from 0.20 to 0.30. The SMI values for the Edenville Dam ranged between 0.5 and 0.9. As expected, the highest SMI values were observed at or around Wixom Lake and the Tobacco and Tittabawassee Rivers, while the lowest SMI values were observed in the urban areas, the land area between the east and west sides of Wixom Lake, and the agricultural fields to the southeast of the Edenville Dam. Areas downstream of the southeast embankment also showed relatively lower temporal variability in the SMI. The SMI scenes in April and May appeared to have less contrast (“blurrier”) between varying land-use types, i.e., urban, agricultural, forested, and water.

The SMI analysis for the Edenville Dam illustrates the variations in relative soil moisture content from April 2016 to May 2020. Consistent soil moisture conditions are to be expected in an earth dam structure constructed with engineered drainage. Relatively higher SMI values are anticipated in the areas near the dam and spillway, which is evident in Figure 6. However, a linear stretch of consistent saturation (or higher SMI values) trending southwest was observed in most of the images. The relatively lower standard deviation of this zone (Figure 6) implies consistent saturation of the zone, suggesting the possibility of perennial subsurface seepage. It is worth noting that the post-dam break river channel developed through this saturation zone. Hence, we argue that the saturated zone perpendicular to the embankment reflects the presence of a potential conduit mechanism for seepage and internal erosion for the embankment failure. Pradel et al. (2021) identified six terrace levels in the vicinity of the dam, where the second and third terrace levels pass beneath the dam at the approximate failure location and correspond to a change in elevation along the base of the dam (~6.6 ft; ~2.0 m) and a change in underlying geology. The association between different terrace treads and glacial stratigraphy implies that the embankment predominantly rests on glacial till of varying ages and physical characteristics. However, in certain areas, the sub-dam stratigraphy is likely composed of glacial outwash and fluvial sands. Since the dam was constructed across these terraces, resulting in lateral variations in the thickness of the embankment and geological substrates (Pradel et al., 2021), these differences in the terraces could likely have facilitated consistent seepage. As previously noted, Pradel et al. (2021)

Figure 5. SMI time series for the 14 Landsat 8 images obtained between April 23, 2016, and May 4, 2020.

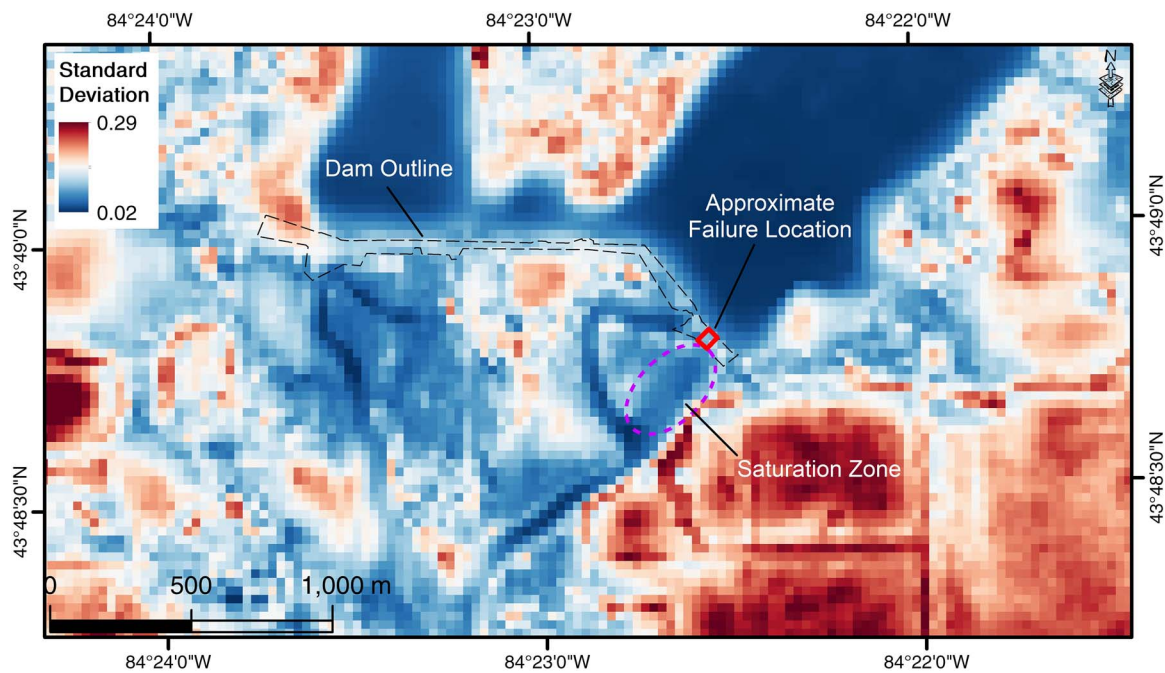
Figure 6. SMI standard deviation for the Edenville Dam area. The dam outline is shown as the black dashed portion. The approximate failure location is outlined in red.
